SLR-VA REPORT

Prepared for California State Parks
September 2024

SEACLIFF STATE BEACH AND NEW BRIGHTON STATE BEACH Sea Level Rise Vulnerability Assessment

Client	California Department of Parks and Recreation
Project name	Sea Level Rise Vulnerability Assessment and Adaptation Alternatives
Document title	Seacliff State Beach and New Brighton State Beach
Document subtitle	SLR-VA Report
Status	Progress Draft
Date	September 25, 2024
Project number	9280-N25
File reference	www.seacliffresilience.org

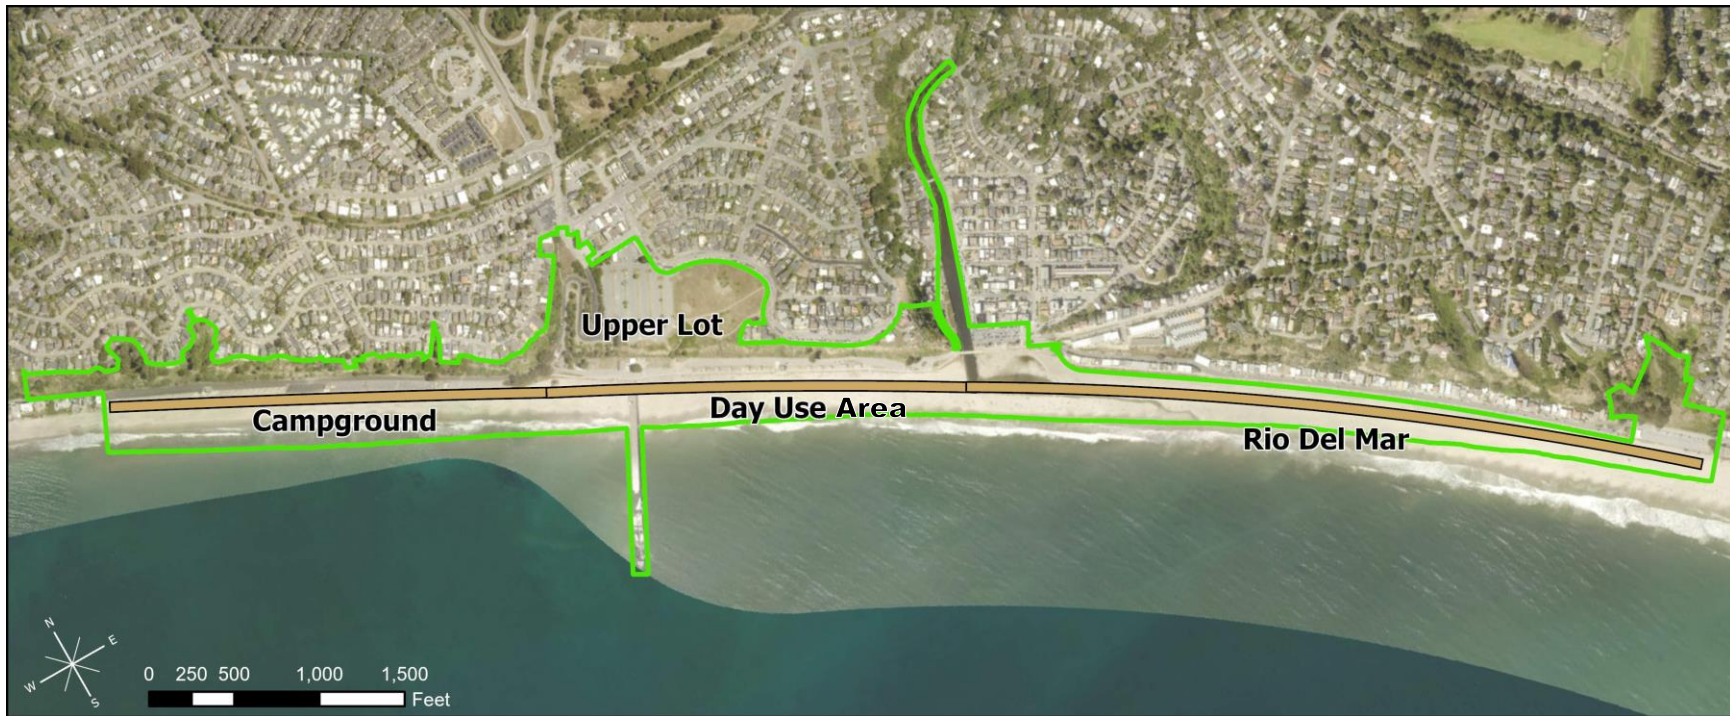
Figure 1-2: Subareas at Seacliff SB.

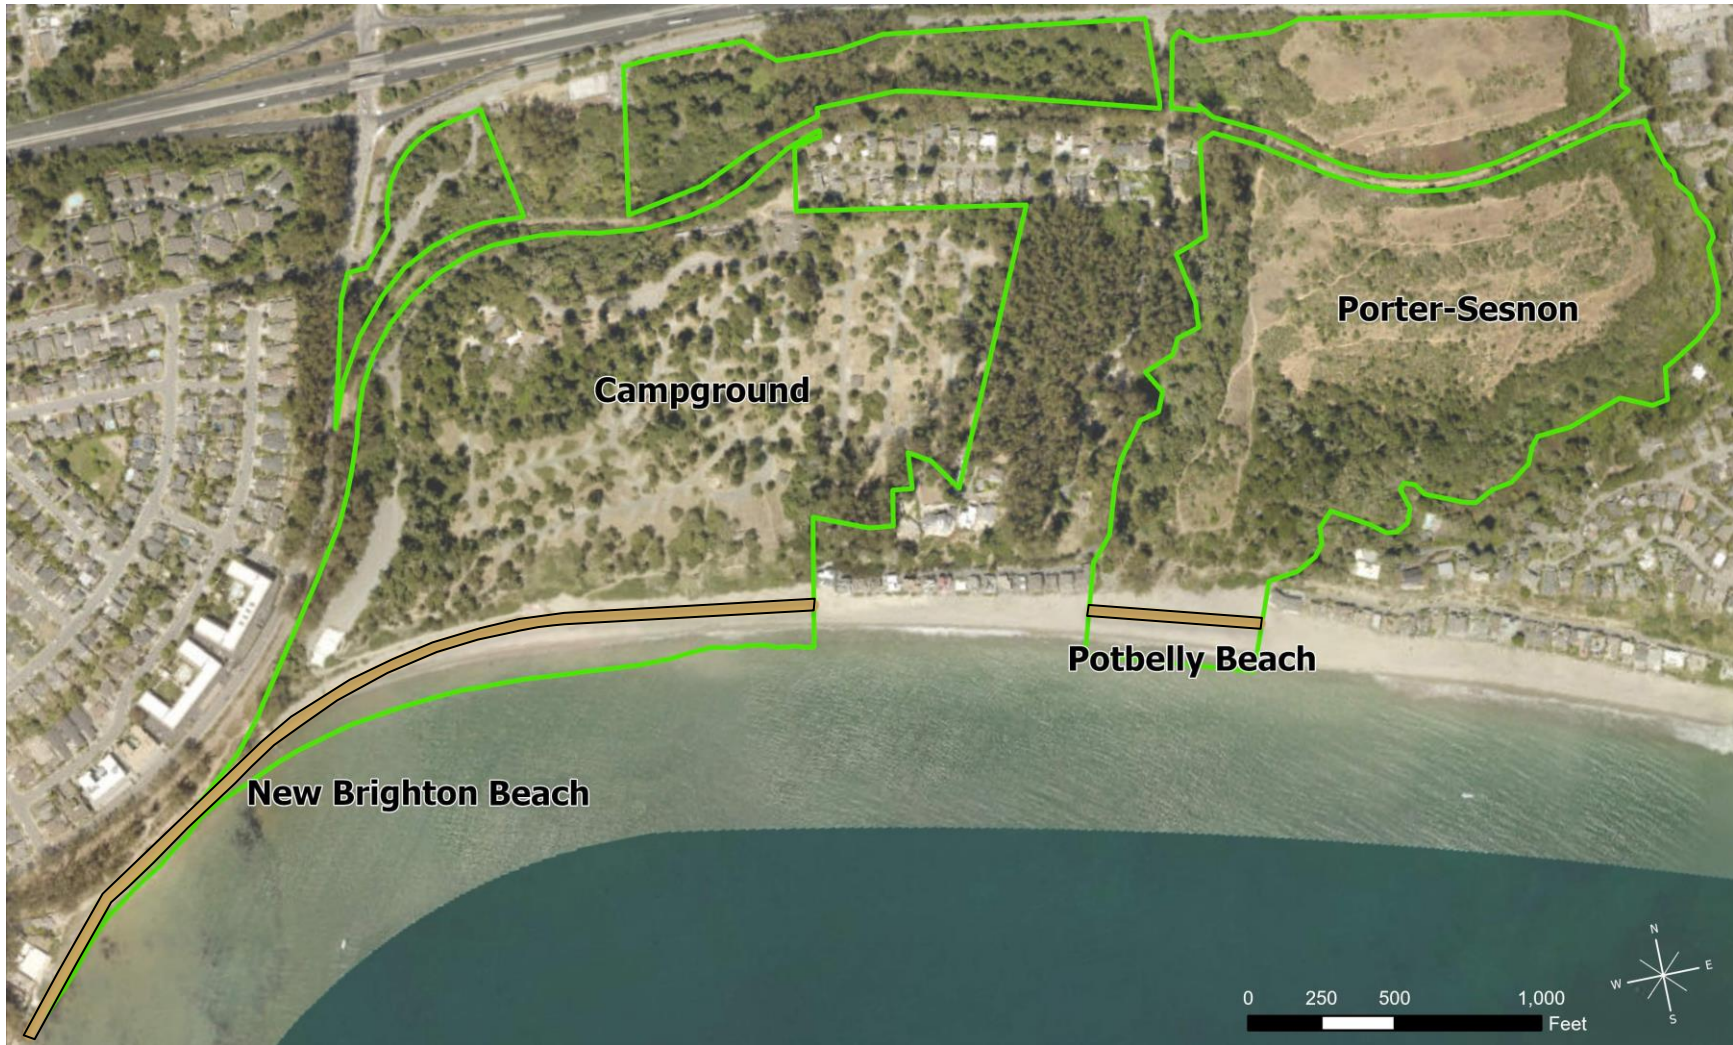
Figure 1-3: Subareas at New Brighton SB.

Refer to Figure 1-3 for an overview of New Brighton SB. The Pacific Migrations Visitor Center at New Brighton enables visitors to learn about the diversity of marine life on the coast, and delve into the cultural resources of the site, which includes Chinese immigrants who occupied a fishing village in the area in the 1870's and 1880's, when it was known as China Beach. New Brighton became a state beach in 1933.

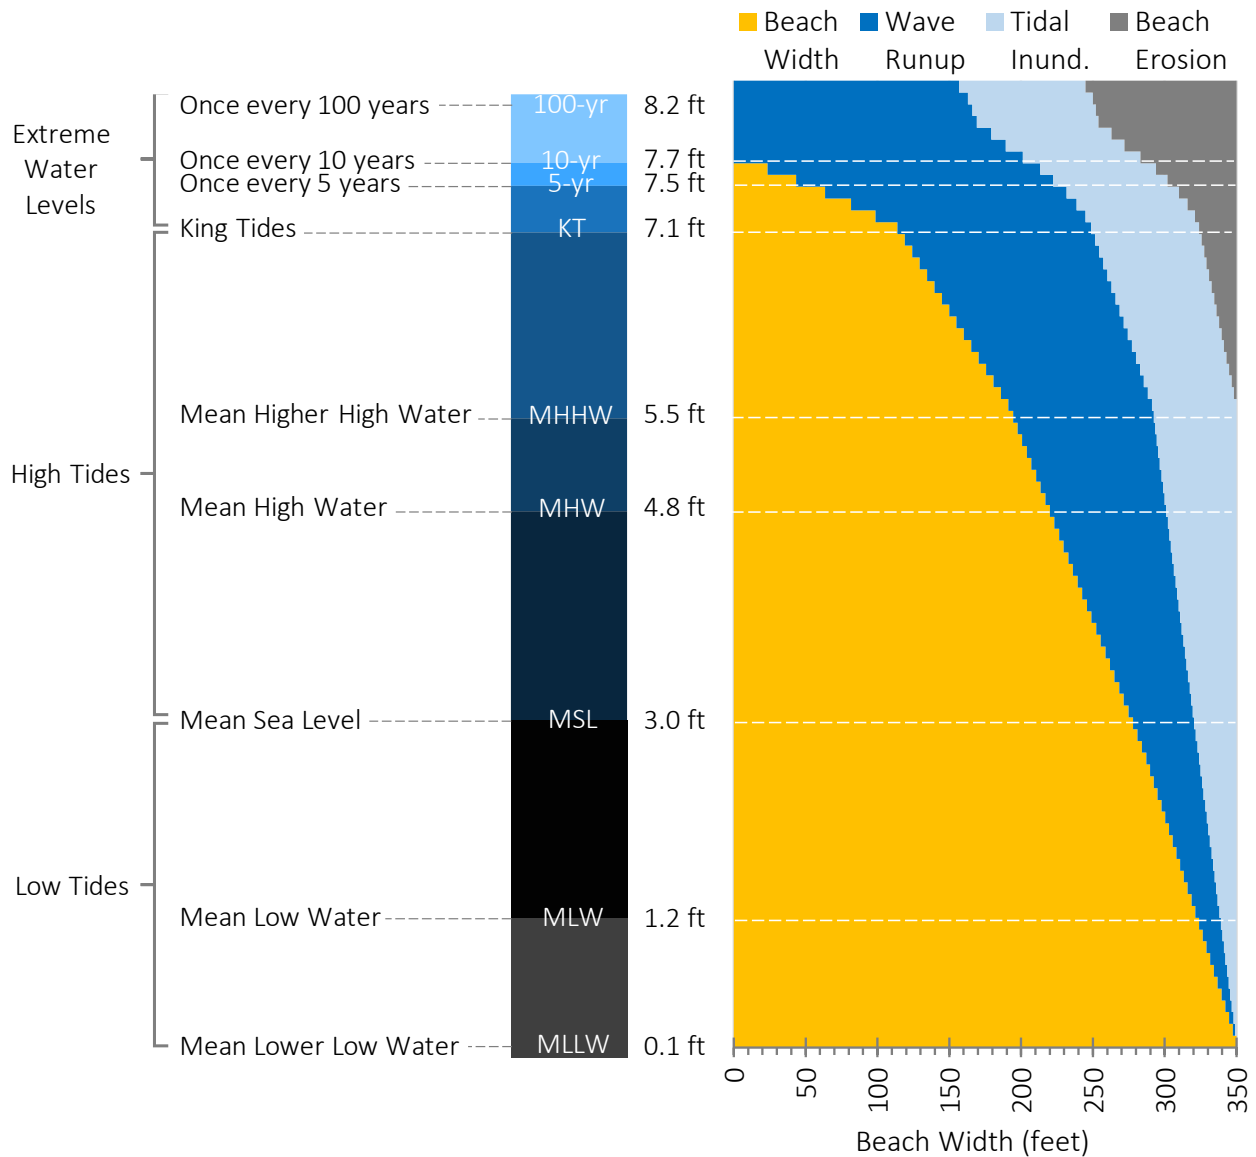
The right side of Figure 2-1 shows how water levels and wave runup affect the beach width at Seacliff and New Brighton Beach, where yellow indicates the beach width, dark blue indicates the extent of wave runup, light blue is representative of tidal inundation, and dark grey signifies beach erosion.

Figure 2-1: Tidal and extreme water levels, beach response at Monterey.

At low tide, the beach can be up to 350 feet wide (bottom of figure) if there is no wave action of significance. Comparing with the MHHW level, it can be seen that the inundation attributed to the normal tide range can cause a reduction in beach width of about 60 feet. During King Tides, about 100 feet of the beach can be subject to tidal inundation.

Wave runup can be responsible for a significant reduction in beach width as well. Under typical wave conditions at MHHW, the beach width can be reduced by about 160 feet, and during king tides and heavy surf reduced by 240 feet.

Above these levels of inundation, beach erosion starts to play a role when storm systems and El Nino conditions increase the water level above the astronomical tide range. As an example, a 5-year storm event may cause about 50 feet of beach erosion and can reduce the beach width to about 40 feet. Similarly, a 10-year storm can reduce the beach width to just a few feet. It is estimated that wave runup associated with 20 to 100-year storms can reach the base of the cliff. Under these conditions there would be no accessible beach width.

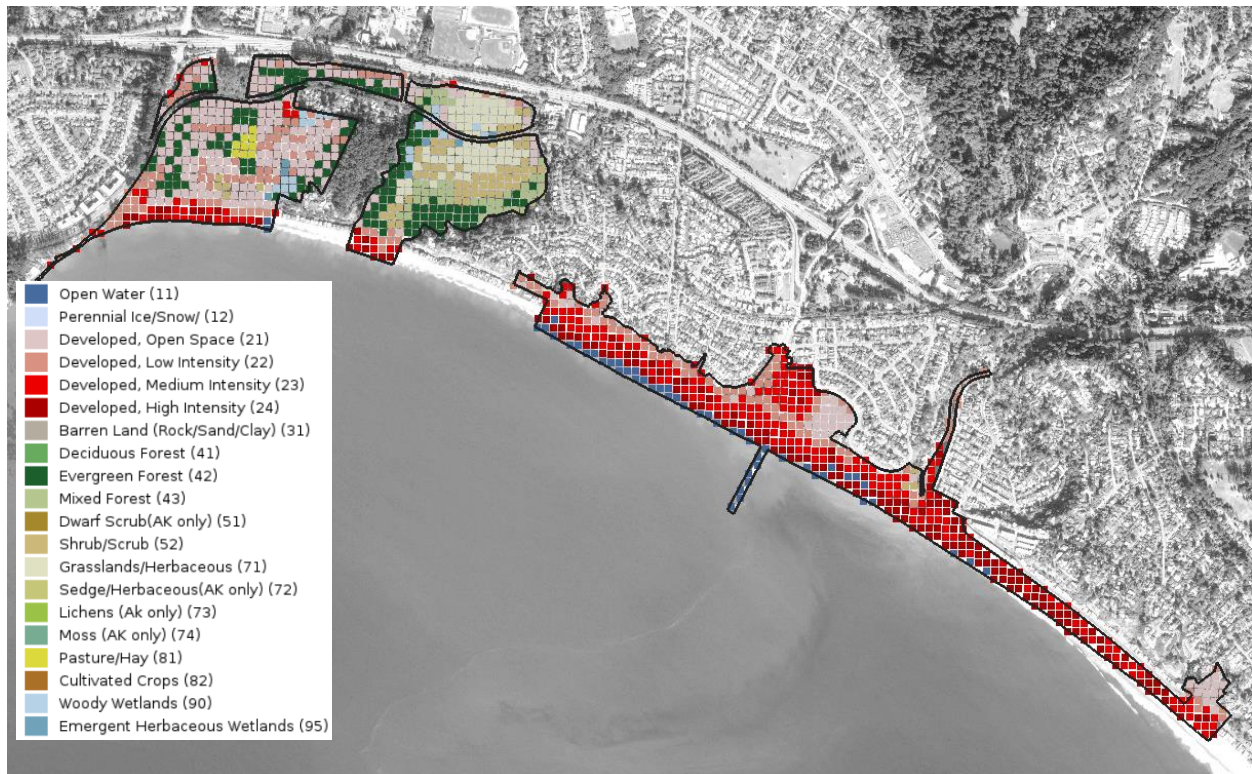
Figure 3-1 provides an overview of the distribution of land cover at Seacliff SB and New Brighton SB, based on CONUS satellite altimetry data from the National Land Cover Database (NLCD), MRLC (2021).

Figure 3-1: Seacliff SB and New Brighton SB Land Cover, NLCD (2021).

Seacliff SB includes areas of developed open space, and medium to high density development. New Brighton SB classifies as developed open space interspersed with evergreen forest and isolated areas

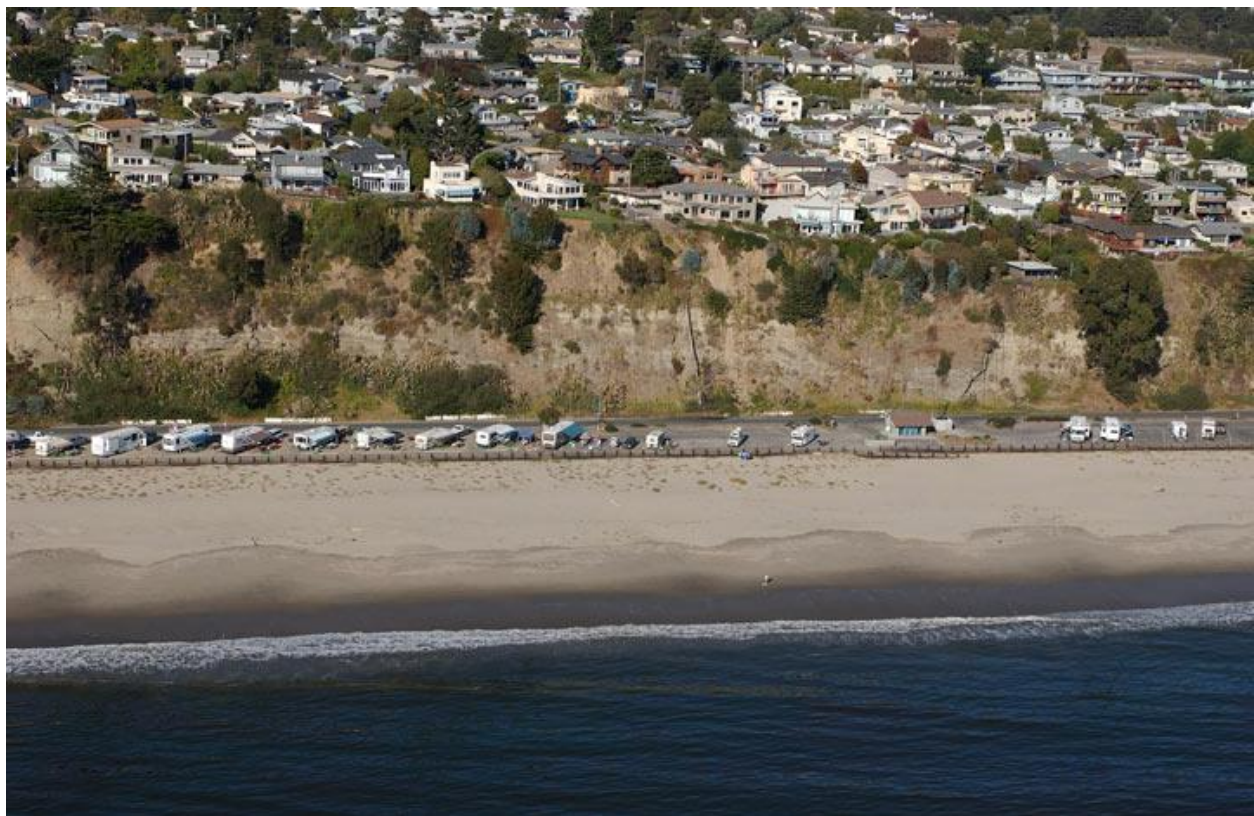
Figure 3-3 shows the Campground located west of the Seacliff Visitor Center. Prior to the January 5, 2023 storm, this area featured a paved pedestrian walkway, 64 RV parking spaces, and 3 ADA accessible restroom facilities with shower facilities, protected by a timber bulkhead fronted by sandy beach. The January storm is estimated to have had a 20-year recurrence interval and caused extensive damage to the RV parking and hookups, and the Seacliff Pier to the point where these facilities had to be demolished and removed. Public access has since been restored and now consists of the roadway at the base of the cliff, fronted by a gently sloping sand fill with a line of rock placed along the toe. Near the entrance to the campground there is access to the Seacliff Visitor Center and Beach Gate Trail.

Figure 3-3: Seacliff Campground, sandy beach backed by road, parking lot, CCRP (2023).

The shoreline consists of sandy beach backed by road, parking, and other infrastructure. This shoreline type has a high sensitivity to shoreline change as the hard backshore features do not allow the beach to migrate landward, resulting in permanent loss of beach.

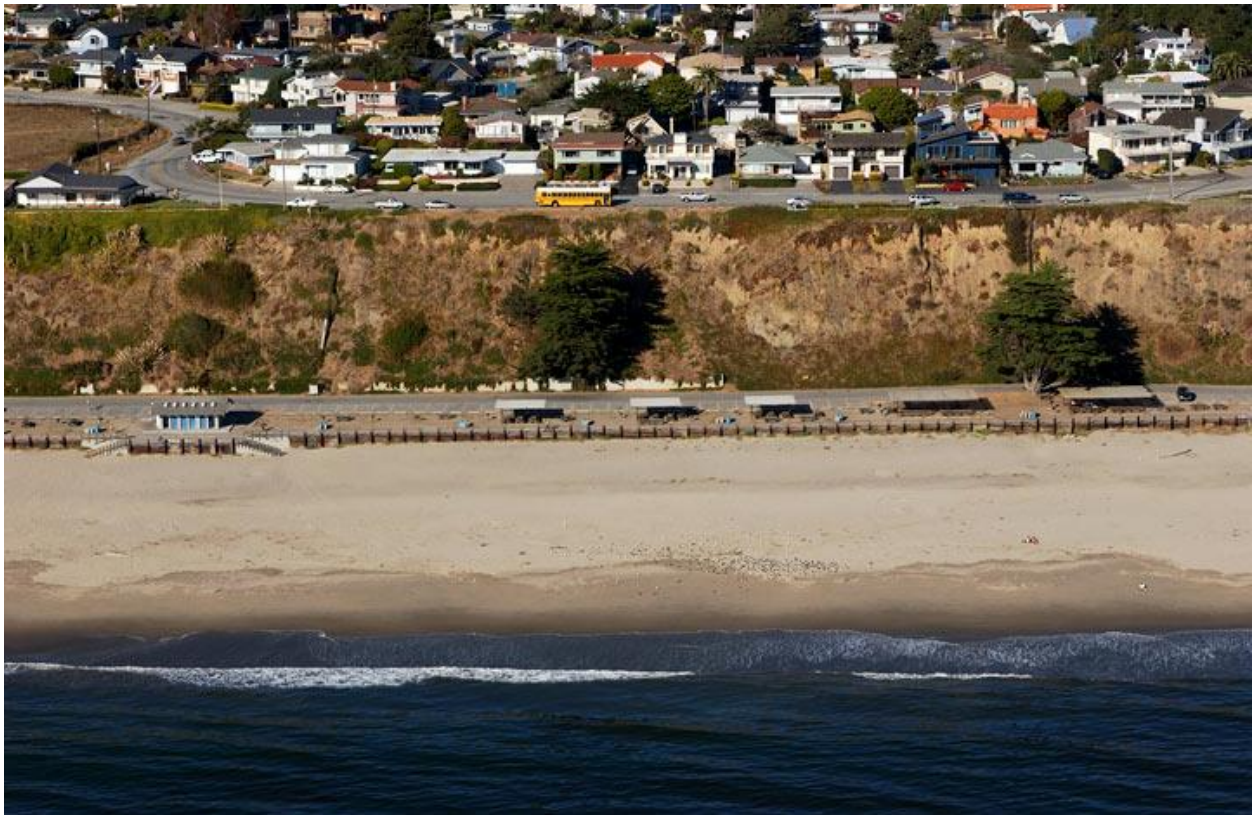
Figure 3-4: Seacliff Day Use, sandy beach backed by seawall, CCRP (2023).

The shoreline at the Day Use area consists of sandy beach backed by road, parking, and other infrastructure. This shoreline type has a high sensitivity to shoreline change as the hard backshore features do not allow the beach to migrate landward, resulting in permanent loss of beach.

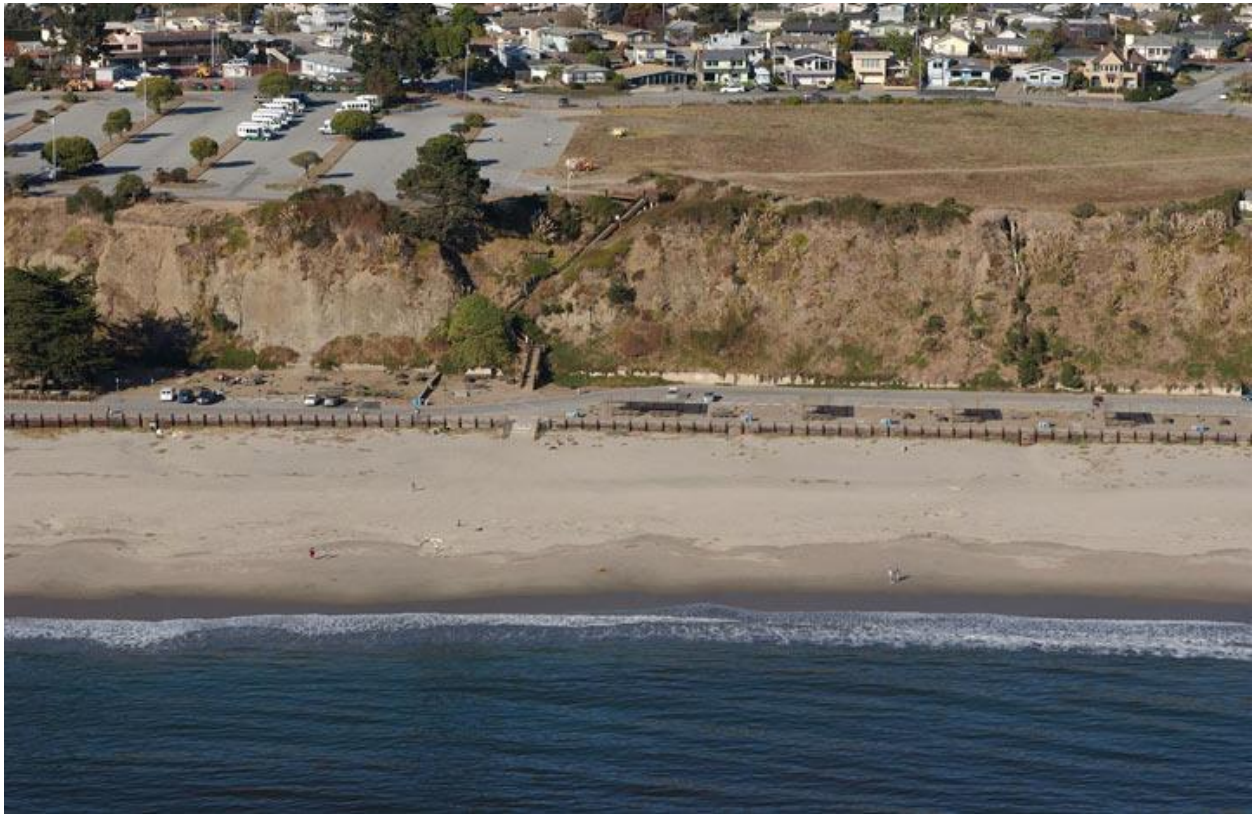
Figure 3-5: Seacliff Upper Lot, CCRP (2023).

The shoreline at the base of the Upper Lot consists of a sandy foreshore backed by road, parking, and other infrastructure. This shoreline type has a high sensitivity to shoreline change as the hard backshore features do not allow the beach to migrate landward, resulting in permanent loss of beach. However, the structures at the base of the cliff limit cliff retreat, reducing the rate of retreat to the base rate.

The Seacliff Upper Lot serves as an overflow parking area when the Campground and Day Use areas fill up, providing paved parking for 365 cars and unpaved overflow parking for 250 cars. Additional facilities at the Upper Lot include a service yard and five employee residences. The area is also used for open space recreation, and at times for storage of Parks equipment, material, and vehicles needing to be serviced. A stairway provides access down to the beach.

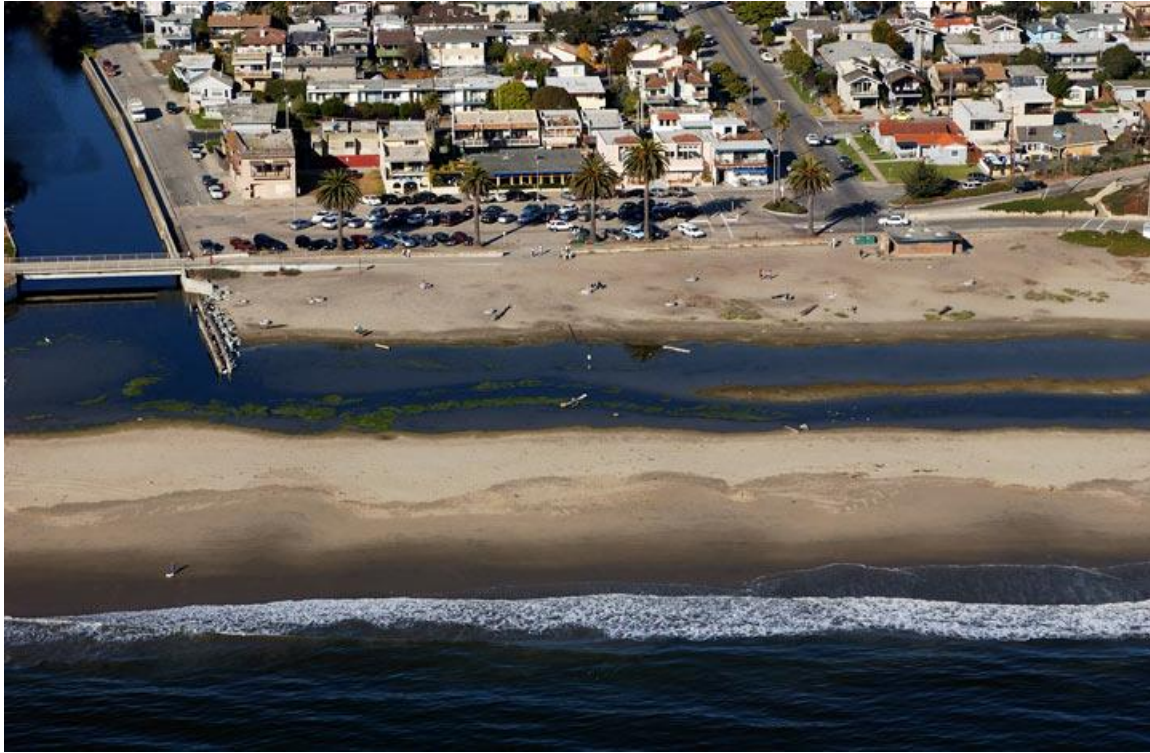
Figure 3-6: Rio Del Mar shoreline at Aptos Creek (left), sandy beach backed by seawall, CCRP (2023).

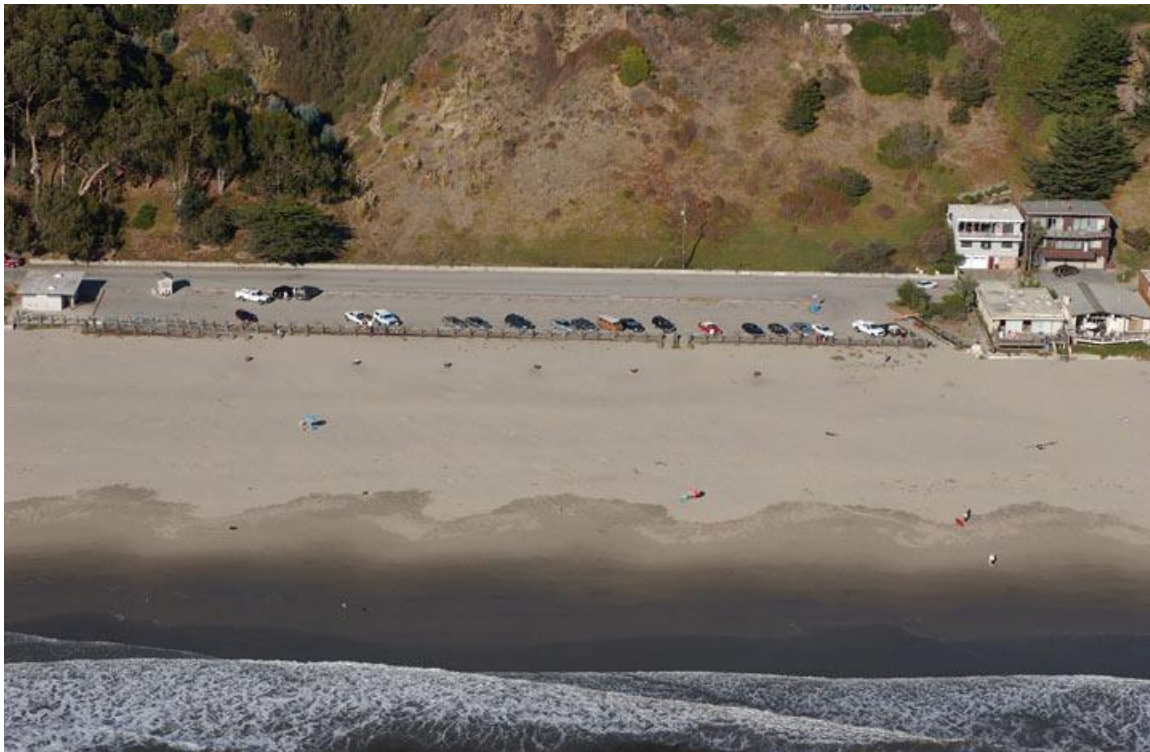
Figure 3-7: Parking area at Rio Del Mar Platforms, sandy beach backed by road, parking, CCRP (2023).

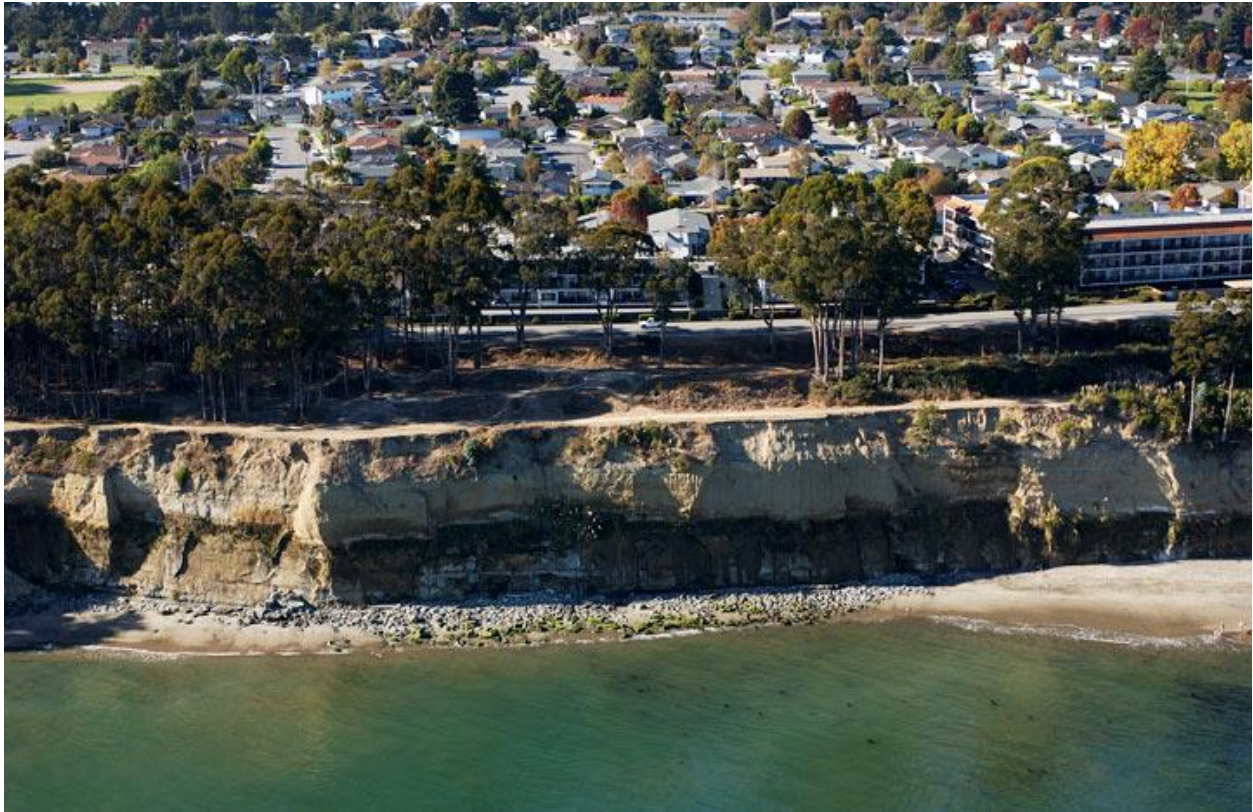
Figure 3-10: New Brighton Beach, rocky shoreline backed by cliff, CCRP (2023).

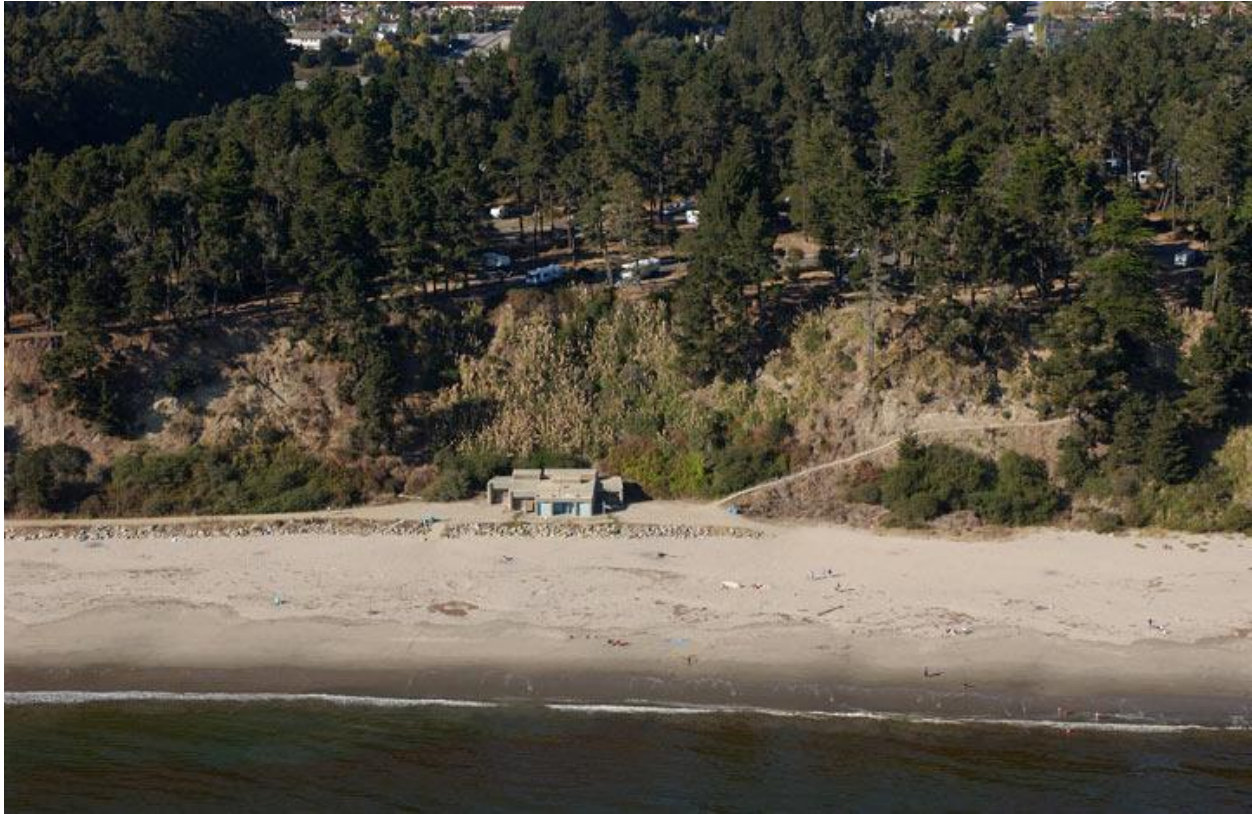
Figure 3-11: New Brighton Beach, sandy beach backed by bluff, CCRP (2023).

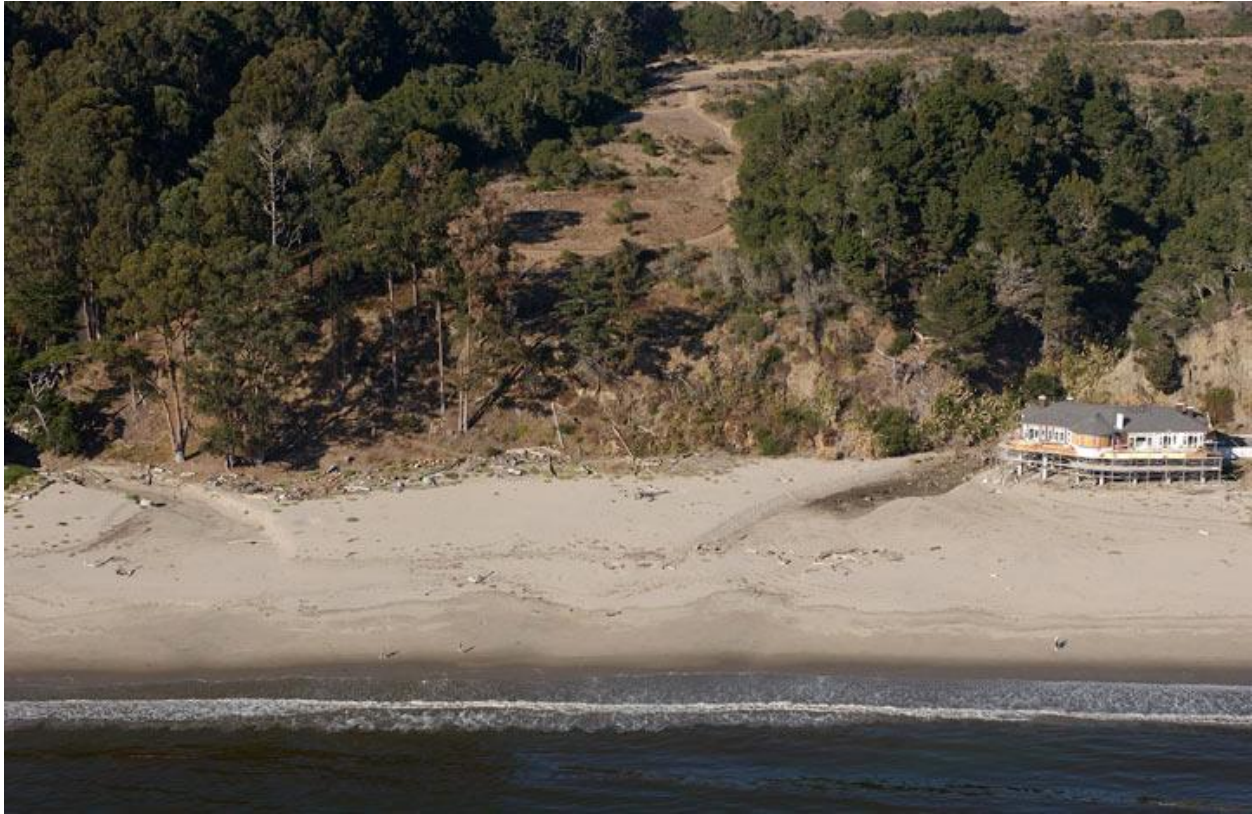
Figure 3-13: Potbelly Beach, CCRP (2023).

The shoreline type at Potbelly Beach consists of sand backed by soft natural bluff. The sensitivity of this shoreline type to shoreline change is moderate, given that the bluff may erode and contribute to accretion of the beach. However, if the beach is eroding at a faster pace than the bluff, loss of beach and reduced beach width will result.

Potbelly Beach is located between private residences at the base of the bluff (Figure 3-13). There is access to Potbelly Beach along the shoreline from New Brighton Beach below mean high tide. Higher tides and wave runup periodically limit access along the beach. From Potbelly Beach, there is a trail connection to the cliff-top Porter-Sesnon area. A ravine on the west side of Potbelly Beach carries Old Woman Creek, which seasonally and intermittently outlets onto Potbelly Beach. The residences to the west of Potbelly Beach are protected with rock armoring. Borregas Creek is located in the ravine at the east end of Potbelly Beach. The residences to the east by the Borregas Creek outlet are located on pile foundations, and the private residences further east are protected with rock armoring.

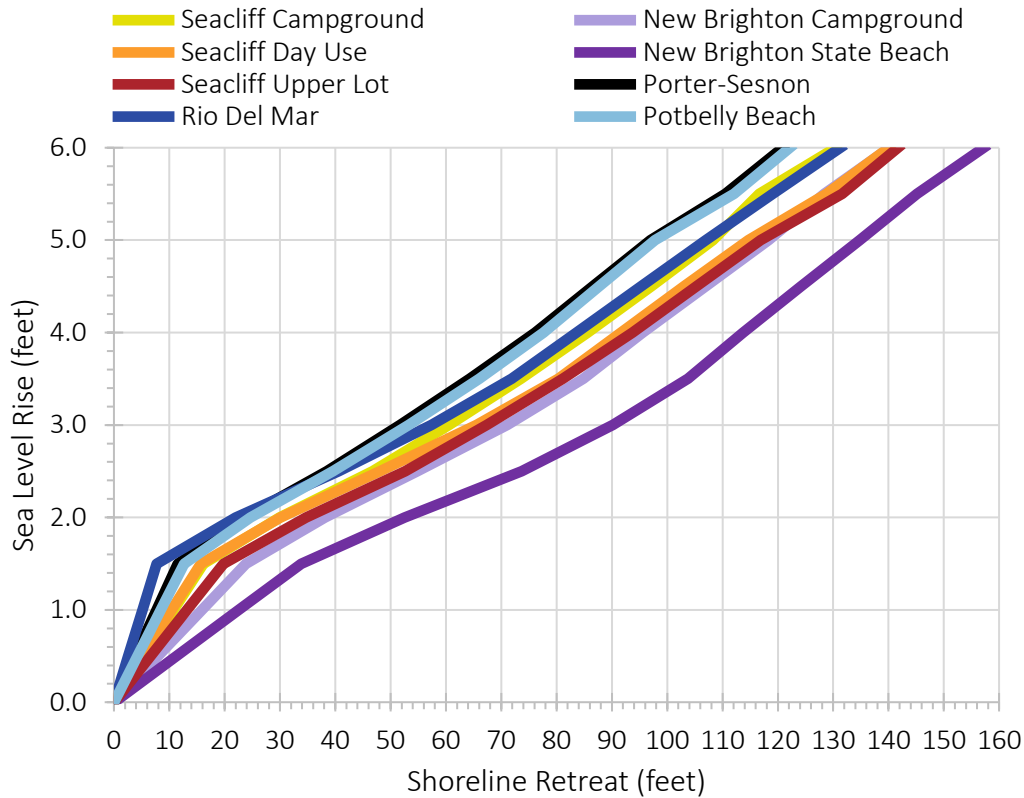
In this study, the extent of shoreline retreat associated with projected SLR was based on shoreline change data for Monterey Bay developed by USGS, depicted in Figure 4-7 based on OCOF (2023).

Figure 4-7: Shoreline retreat with SLR, OCOF (2023).

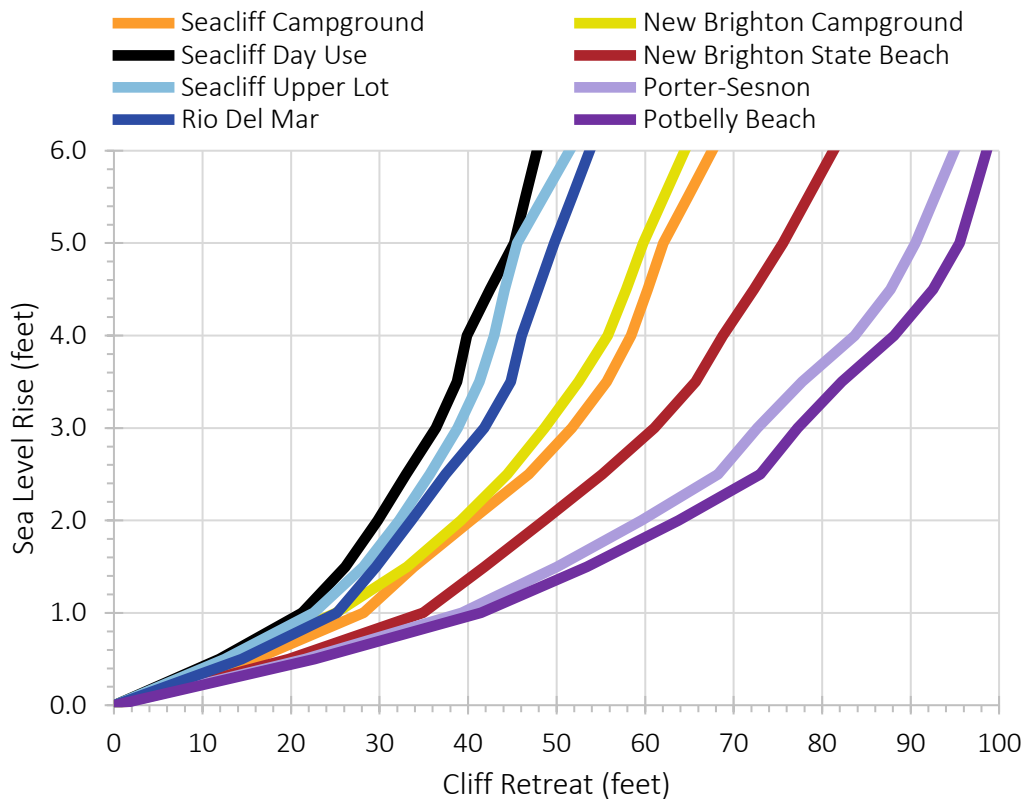
Rates of cliff retreat adopted for this study were based on USGS data as summarized in Figure 4-9 based on data from OCOF (2023). These rates of cliff retreat are a function of SLR and assume that the base of the cliff is exposed to coastal hazards and part of the active shoreline processes.

Figure 4-9: Cliff retreat with SLR, OCOF (2023).

In reality, the cliff retreat is limited by the presence of structures and coastal armoring at the base of the cliff. In the USGS CoSMoS model, this is treated as a toggle to either “hold the line” (prevent cliff retreat) or “not” (permit cliff retreat as a function of SLR). This study considered the intermediate condition where structures at the base of the cliff provide protection up their wall/structure crest elevation, and the portion of the cliff above that subject to retreat if exposed to SLR.

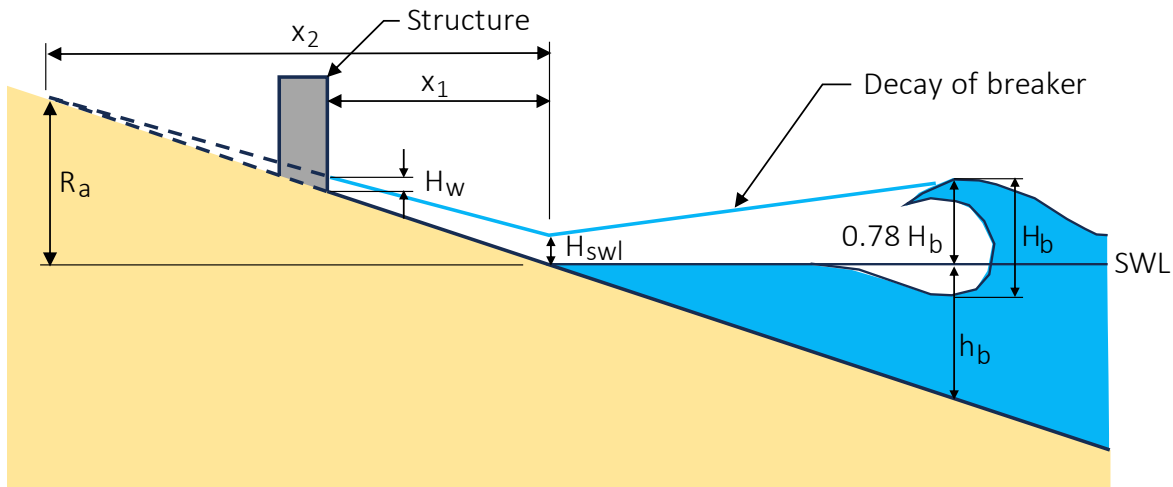
Flood depths and wave impacts were determined based on the methodology from the Coastal Engineering Manual depicted in Figure 4-12 from CEM (2011). The flood depth, H_w , at a structure located at a distance of X_1 from the waterline (SWL) is related to the breaking wave height, H_b , and wave runup R_a past the structure.

Figure 4-12: Exposure of structure to wave runoff, CEM (2011).

The flood depth, H_w , can be described as:

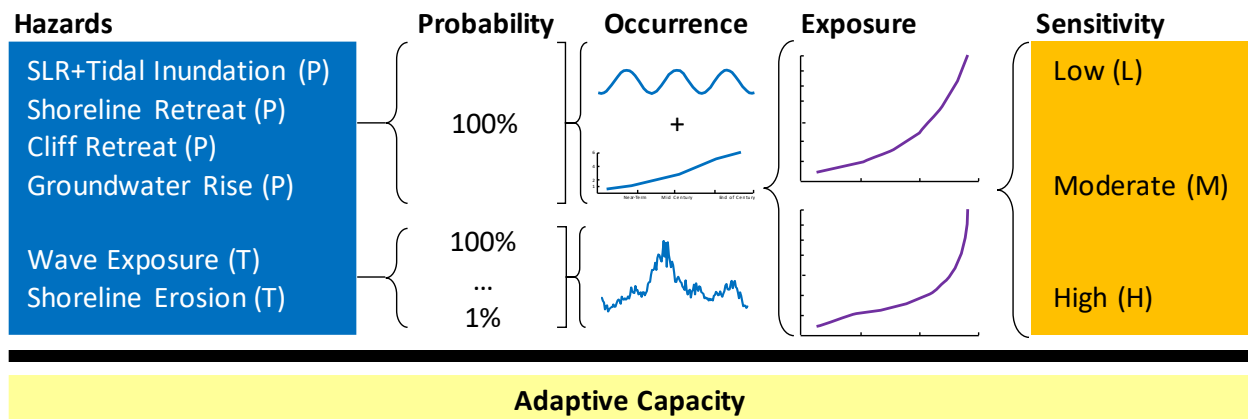
The temporary hazards occur by random processes and are transient, reverting to an equilibrium state after the exposure event. For example, heightened wave exposure, storm surge and beach erosion are anticipated with the passage of winter storms, after which waves exposure falls back to a base level and eroded beach areas start to gradually recover, returning to the seasonal equilibrium beach width. As wave exposure is predominantly associated with winter storms, the base shoreline position is considered to be the winter beach profile. The level of wave exposure during a storm event is unknown and an outcome of a random process. Wave exposure and wave-driven beach erosion are therefore evaluated based on their probabilities of occurrence. As an example, winter storms occurring annually are assigned an annual probability of 100%. Storms with a recurrence interval of 5 years are assigned an annual probability of occurrence of $1/5 = 20\%$ chance of occurrence. Storms having a 10-year recurrence interval have an annual probability of $1/10 = 10\%$ chance of occurrence and so forth. A 100-year storm event could be highly damaging but has a limited chance of occurring of $1/100 = 1\%$ each year.

Figure 4-14: Asset vulnerability analysis.
