SLR-VA REPORT

Prepared for California State Parks
September 2024

SEACLIFF STATE BEACH AND NEW BRIGHTON STATE BEACH Sea Level Rise Vulnerability Assessment

Client	California Department of Parks and Recreation
Project name	Sea Level Rise Vulnerability Assessment and Adaptation Alternatives
Document title	Seacliff State Beach and New Brighton State Beach
Document subtitle	SLR-VA Report
Status	Progress Draft
Date	September 25, 2024
Project number	9280-N25
File reference	www.seacliffresilience.org

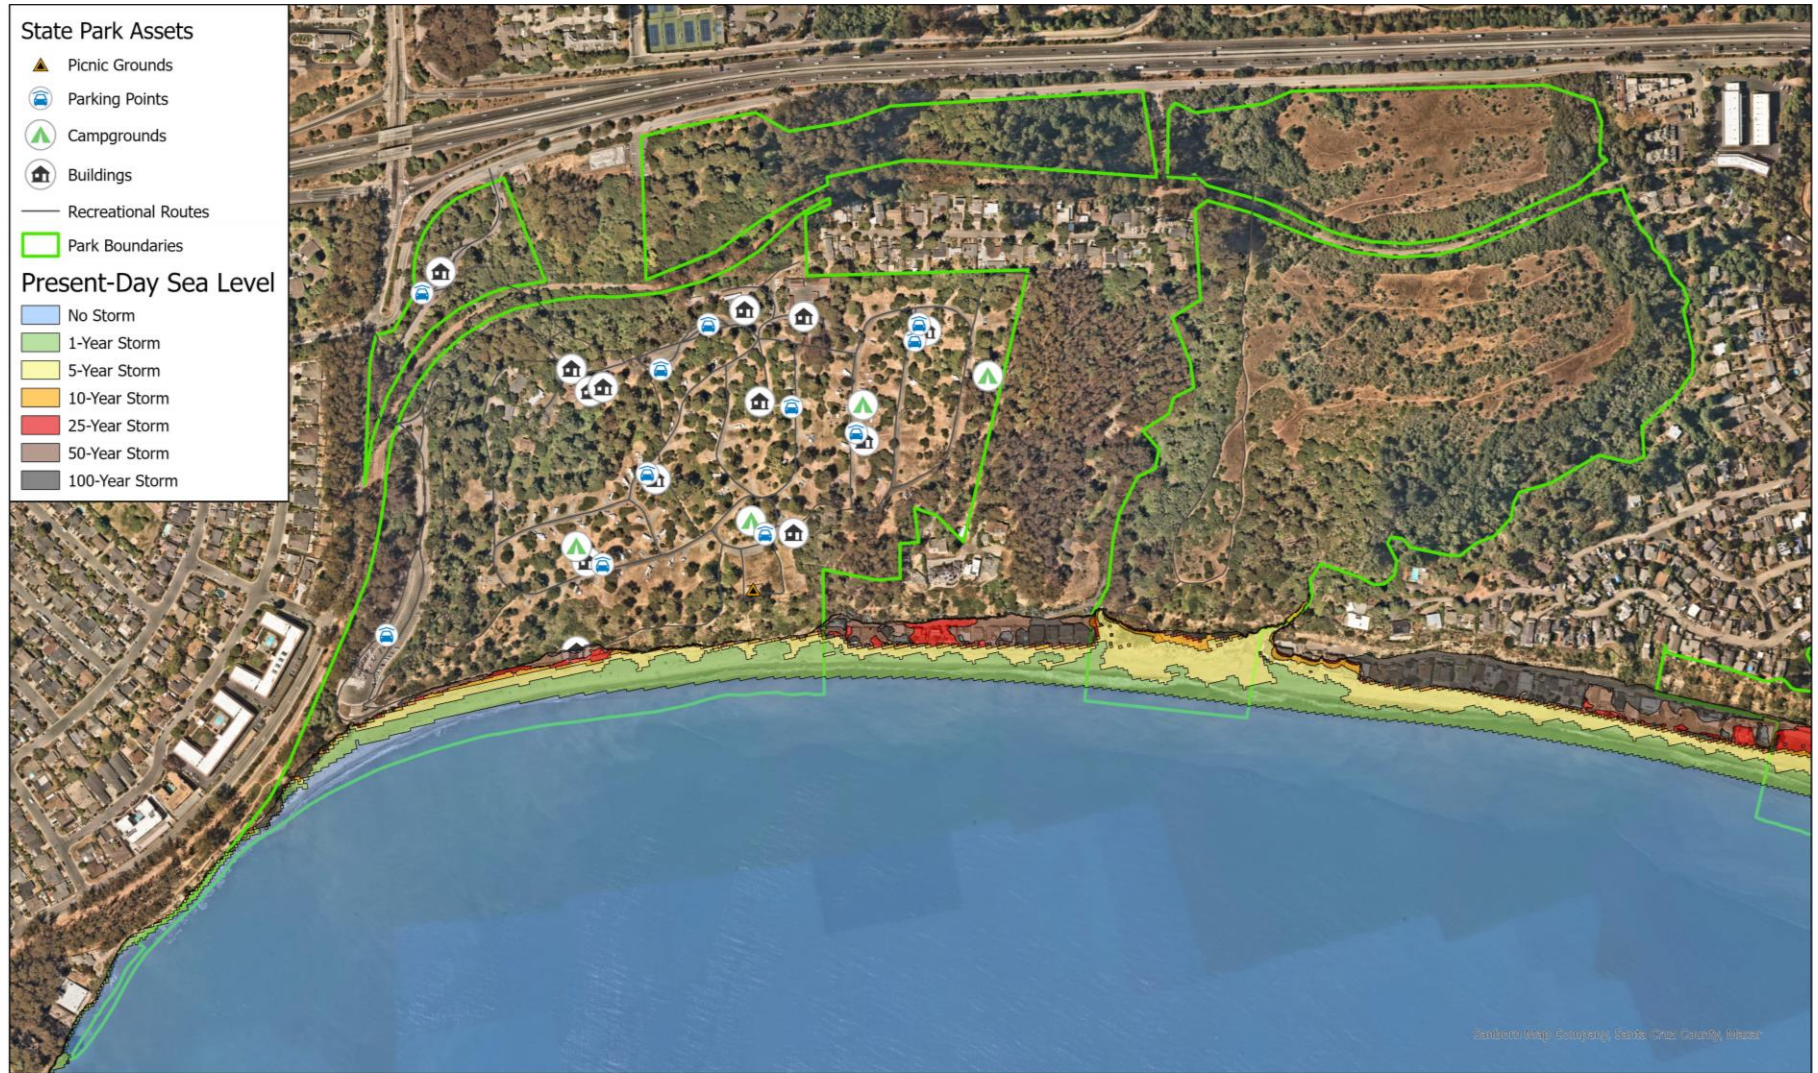
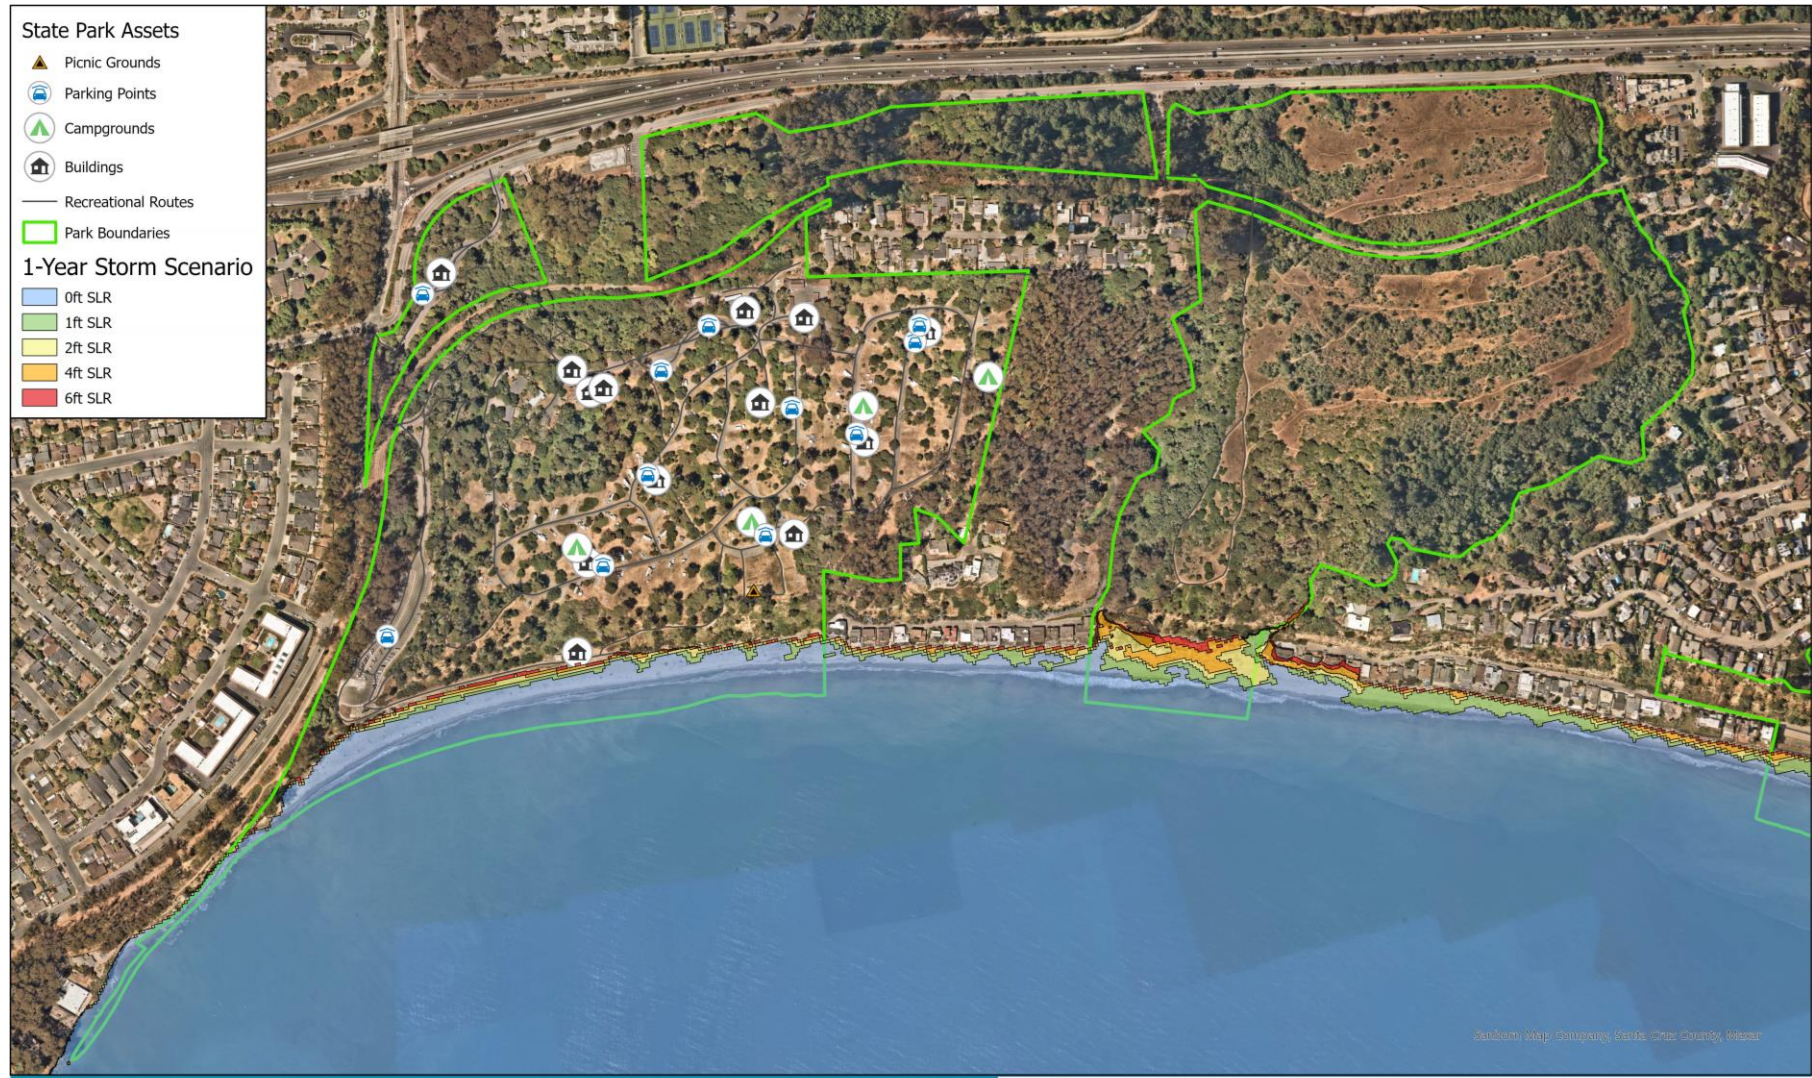
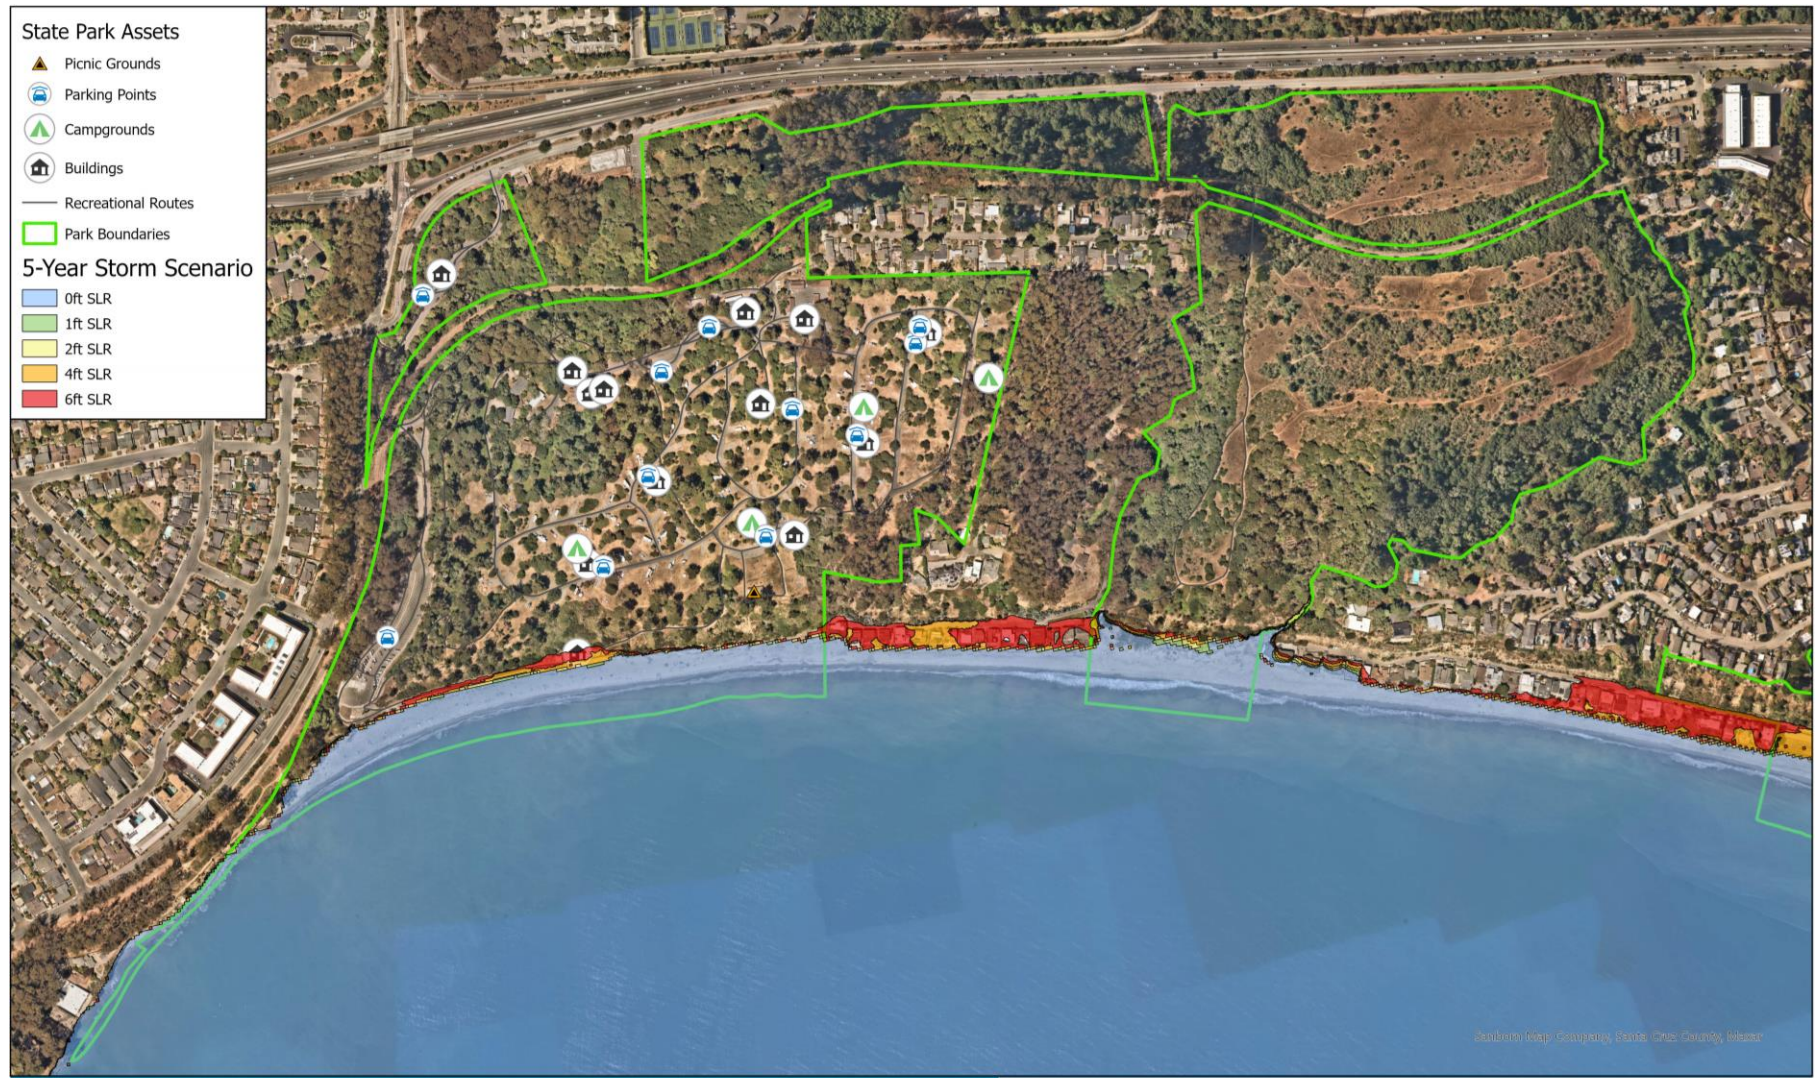
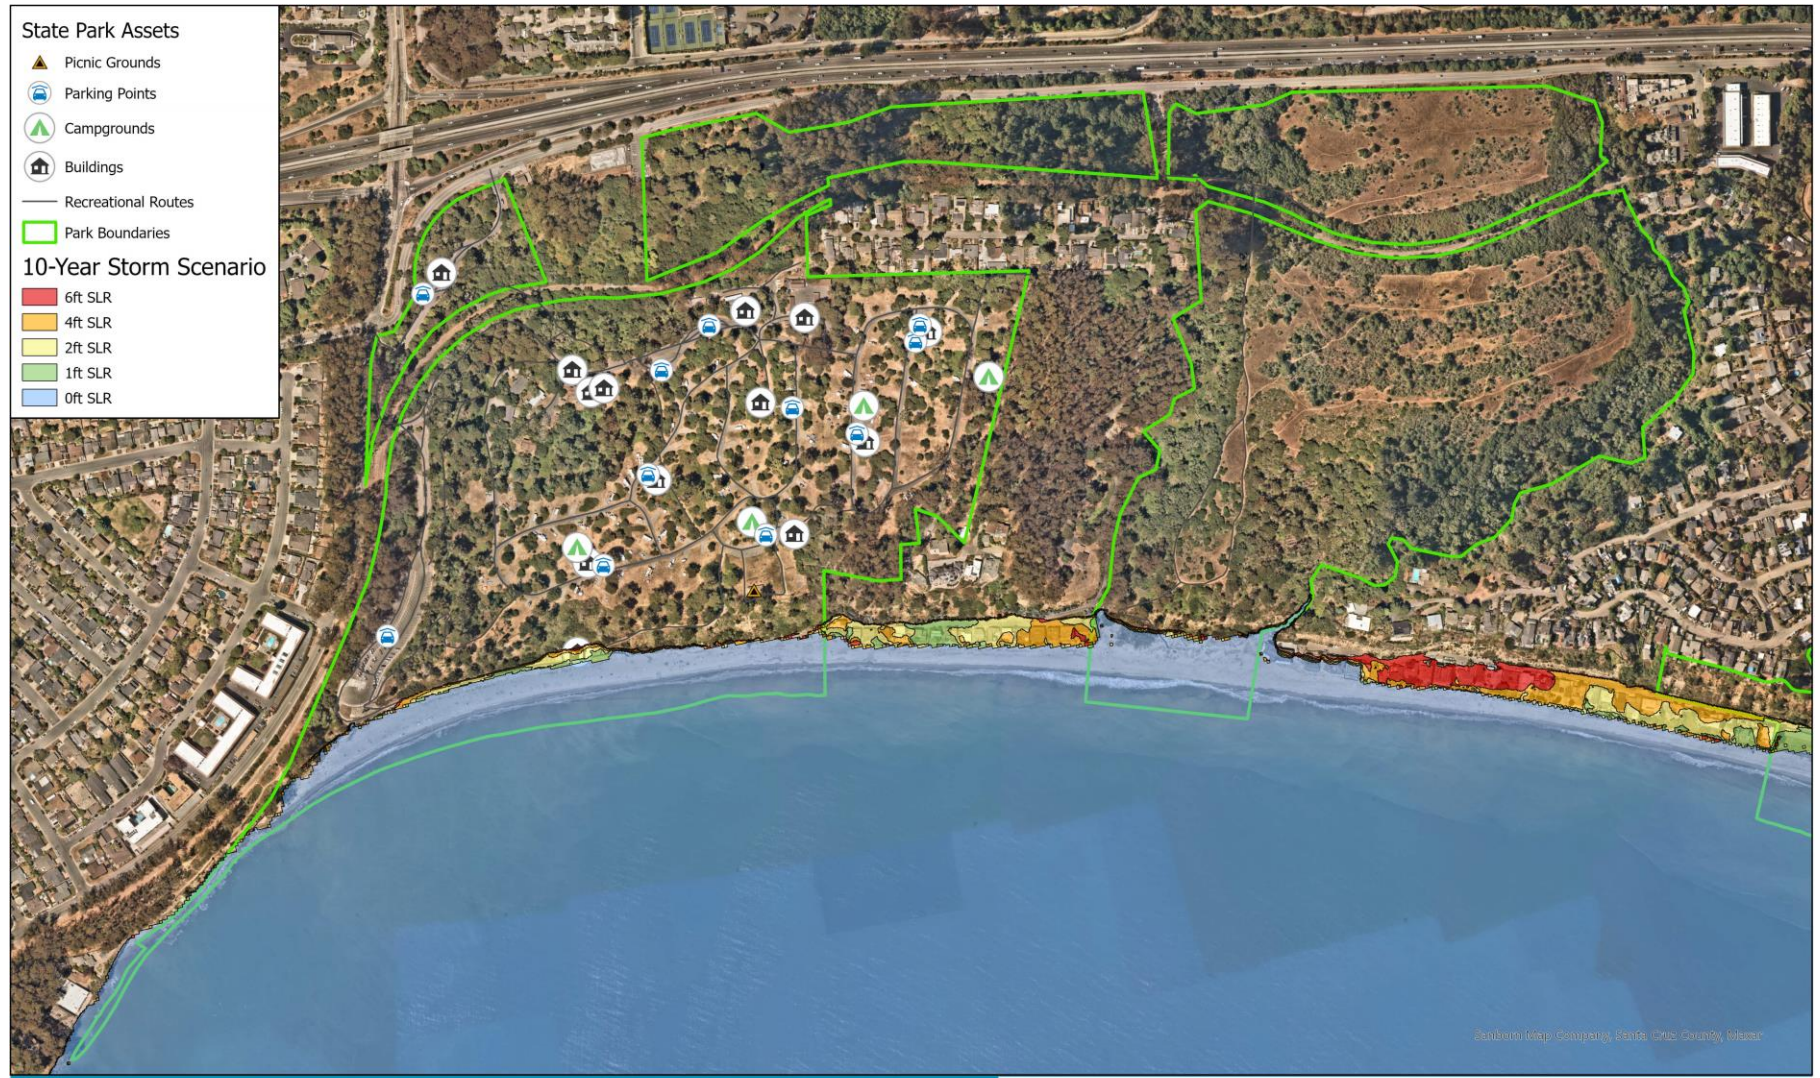
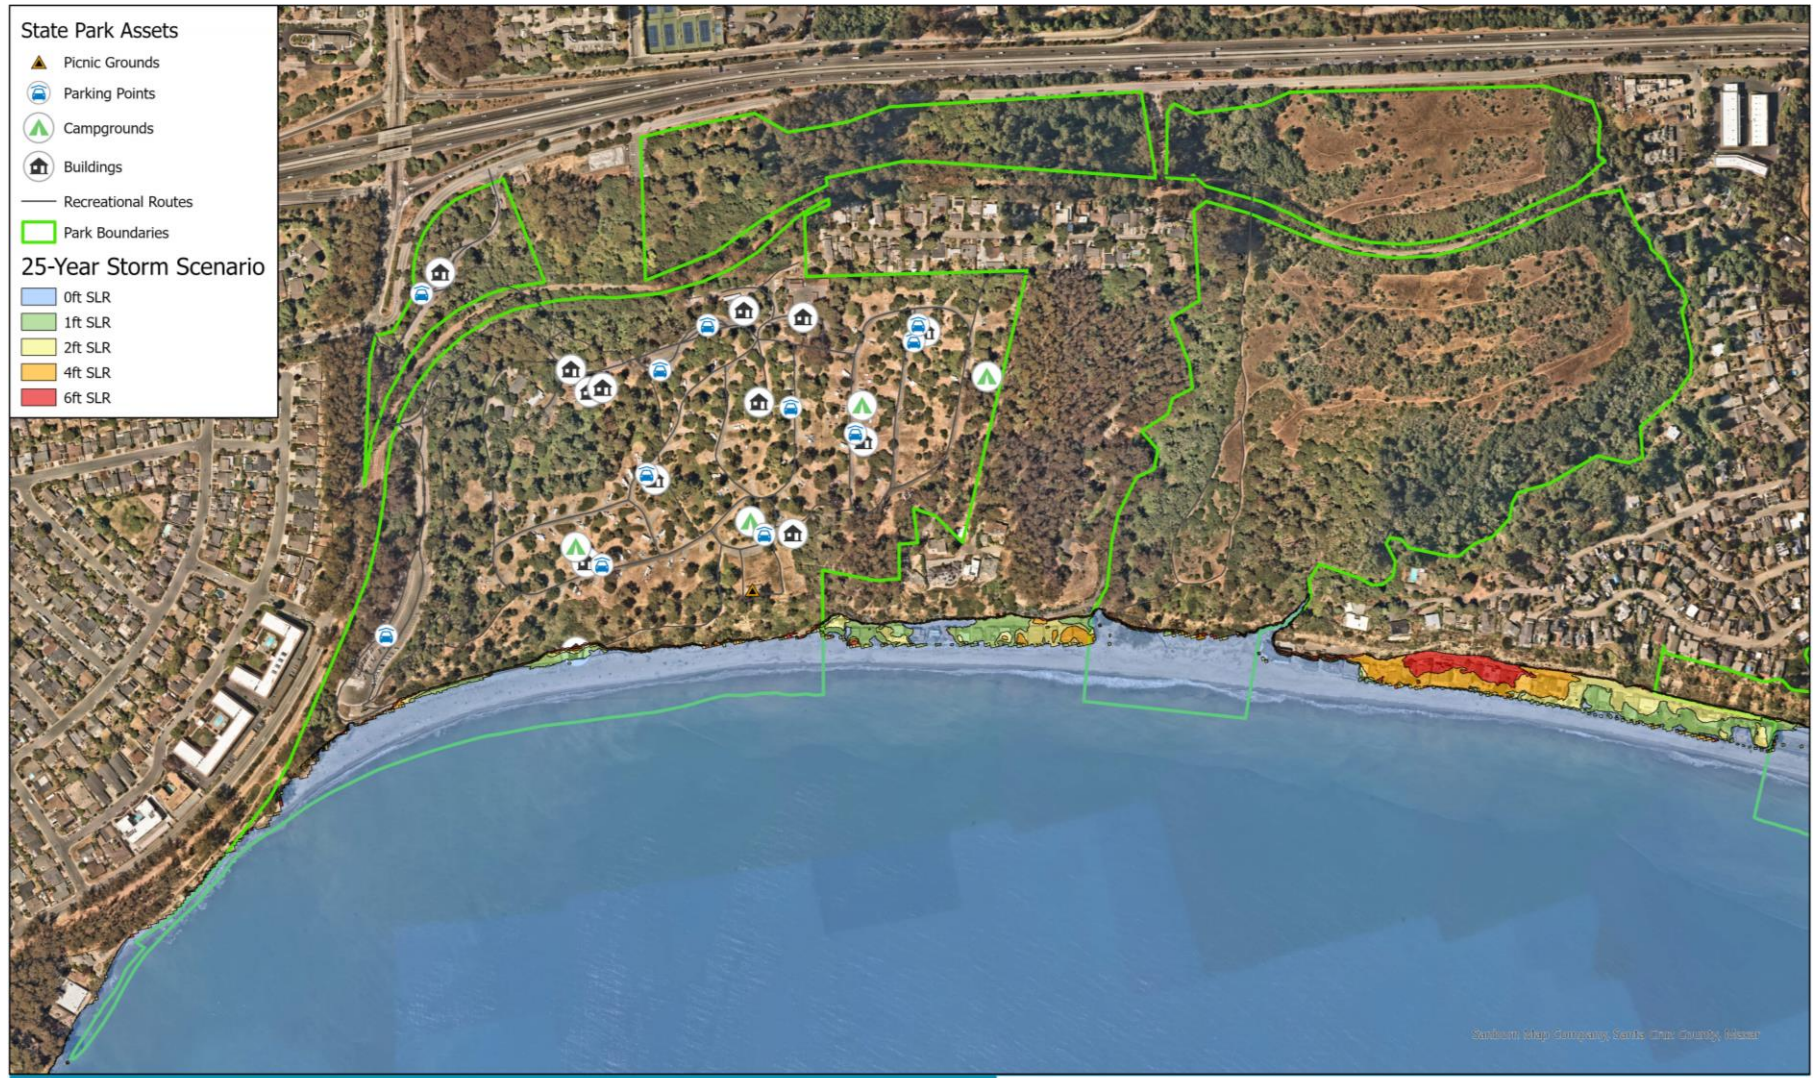
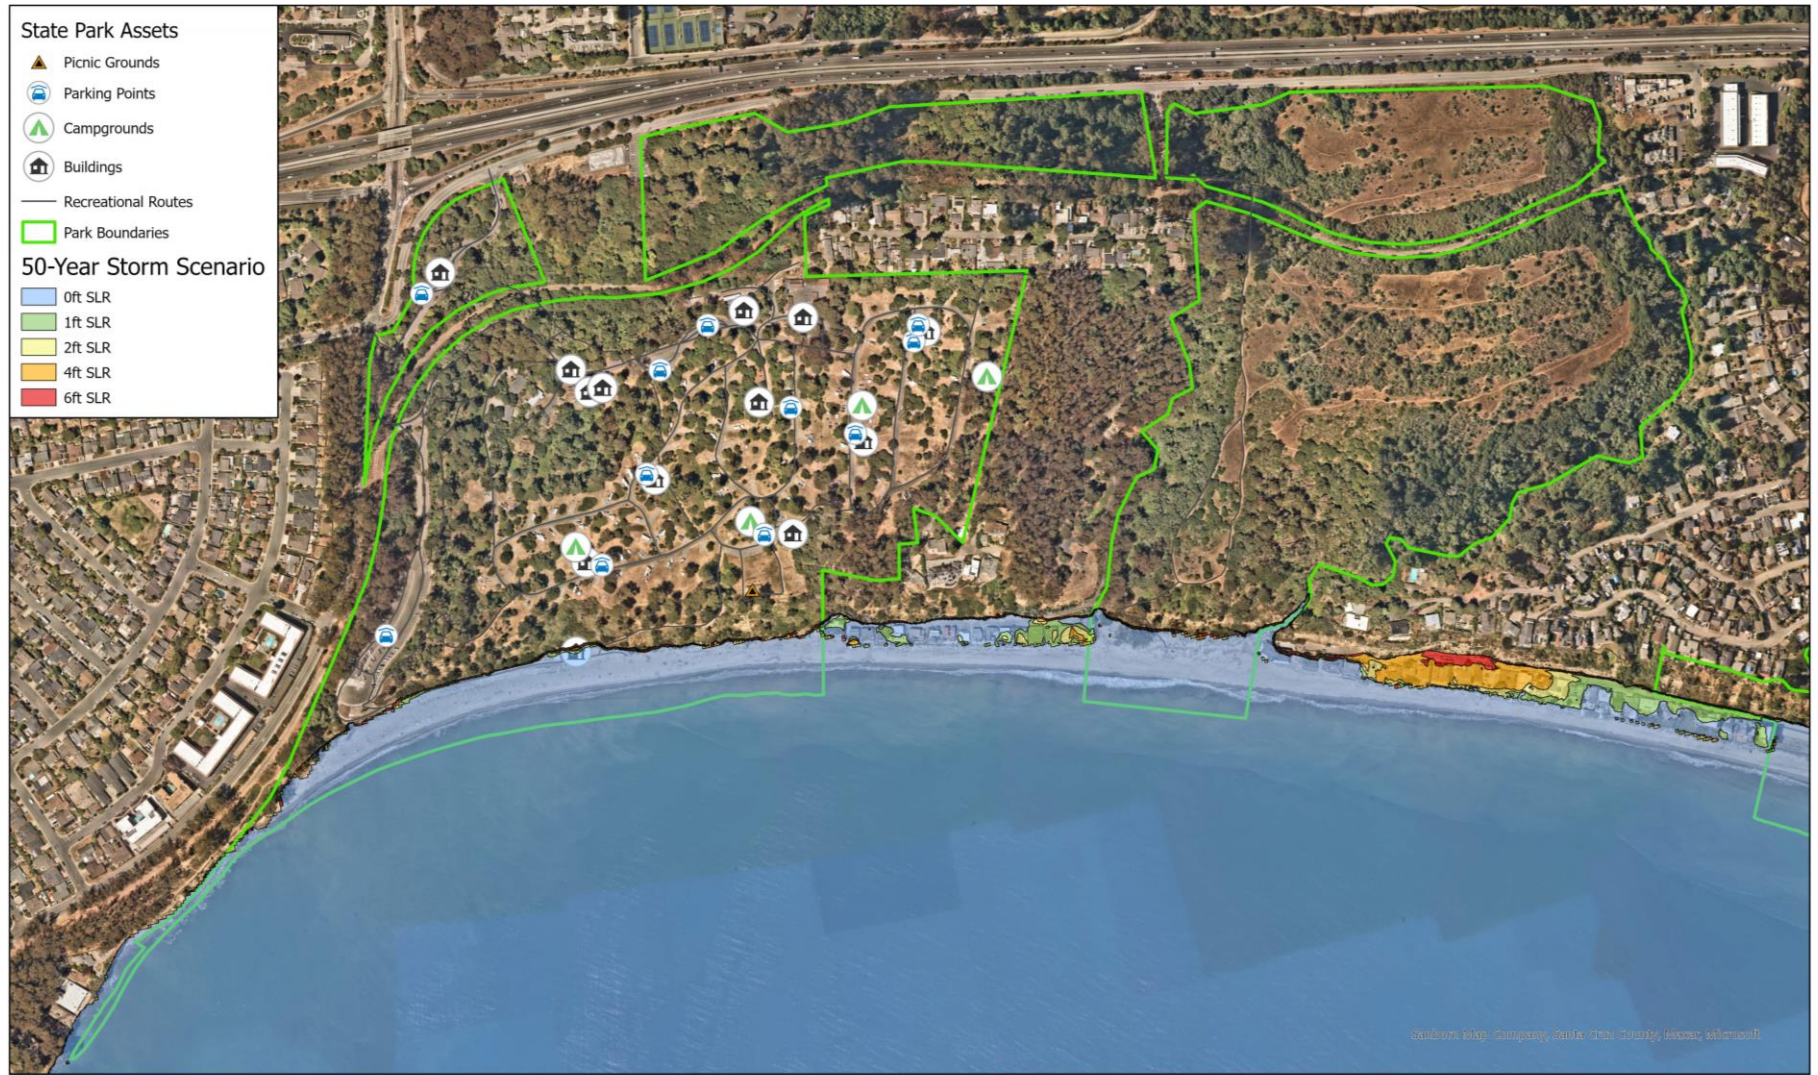
1. Flood extent at New Brighton SB for non-storm, and 1 to 100-year flood hazards at present-day sea level.
2. Flood extent at New Brighton SB for 1-year storm events with 0 to 6 feet of sea level rise.
3. Flood extent at New Brighton SB for 5-year storm events with 0 to 6 feet of sea level rise.
4. Flood extent at New Brighton SB for 10-year storm events with 0 to 6 feet of sea level rise.
5. Flood extent at New Brighton SB for 25-year storm events with 0 to 6 feet of sea level rise.
6. Flood extent at New Brighton SB for 50-year storm events with 0 to 6 feet of sea level rise.
7. Flood extent at New Brighton SB for 100-year storm events with 0 to 6 feet of sea level rise.
